Partridge Lake Watershed Based Plan

Prepared for:

Partridge Lake Property Owners Association

February 2008

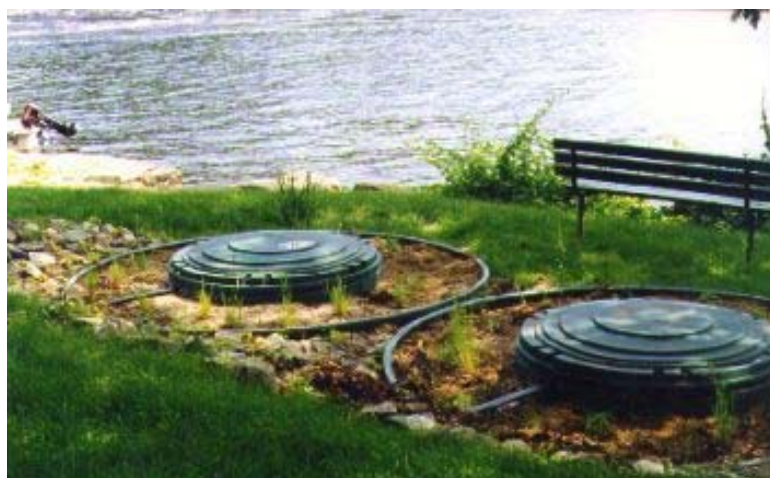
Figure 3-2: Example StormTreat System Installation.

The wetland is comprised of a gravel substrate planted with bulrushes and other wetland plants. Unlike most wetlands constructed for stormwater treatment, StormTreat conveys stormwater into the subsurface of the wetland and through the root zone, where greater pollutant attenuation occurs through such processes as filtration, adsorption, and biochemical reactions. The operation and maintenance of the StormTreat System is limited to annual inspections and solids removal on an as-needed basis.

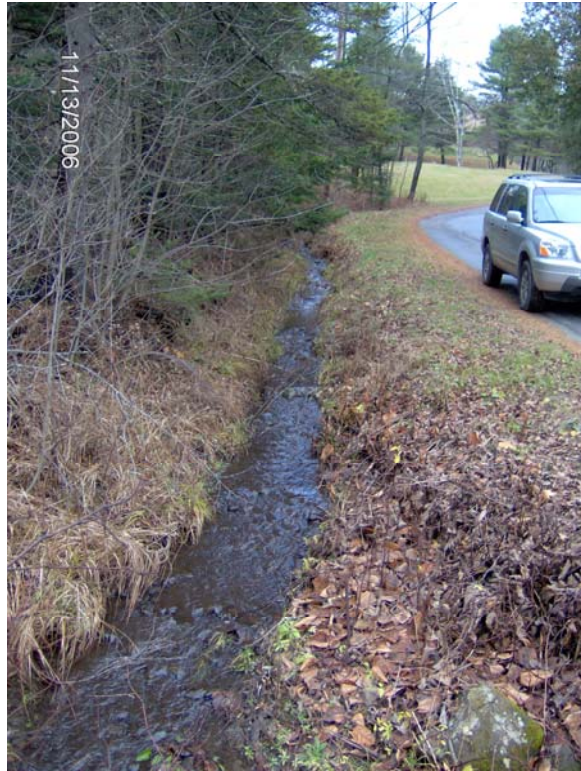
Tributary J drains a forested section of the watershed north of the lake (Figure 3.5). The lower portion of the stream runs through residential areas and crosses under Partridge Lake Road before entering Partridge Lake. Phosphorus loading from this subwatershed from June 2000 through May 2001 was calculated to be 3.9 kg/yr.

Photo: Tributary J running along Partridge Lake Road.

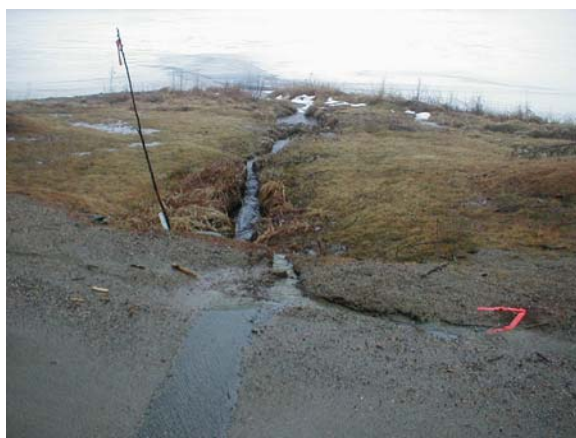
Photo: Run-off over Partridge Lake Road entering Tributary A.

Another essential component at this location is maintenance, either in the form of clean-up along existing roads during the spring and maintenance of any BMP that may be installed for runoff and sediment control. Town participation is essential.

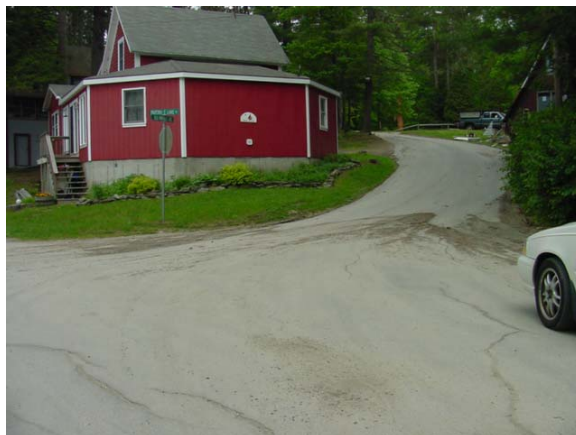
Photo: Sediment deposited on Old Partridge Lake Road after storm.

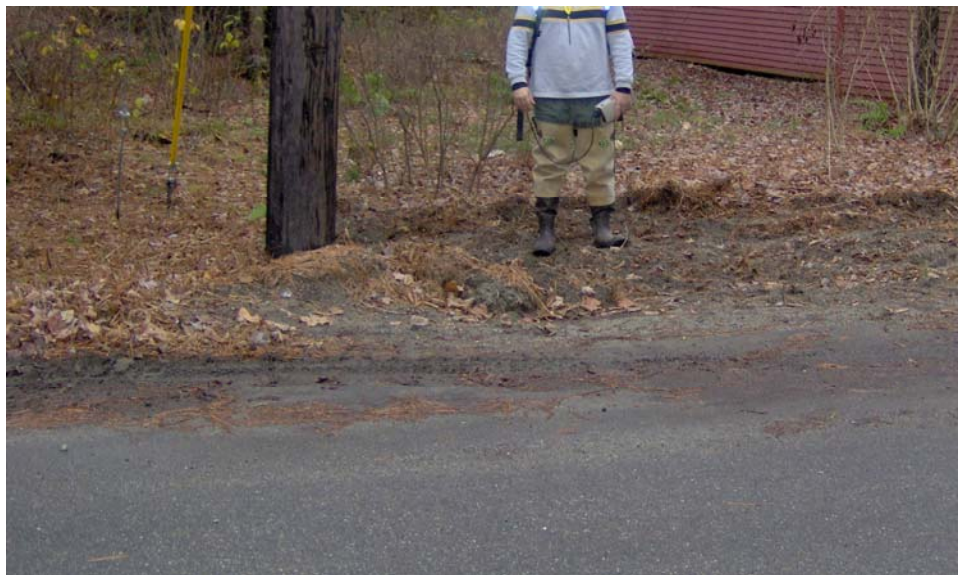
Regular street sweeping helps to prevent deposition of sediment into surface waters by wash-off. Currently the town provides street sweeping around Partridge Lake in the spring once per year with a vacuum assisted wet sweeper and a bucket sweeper. PLPOA members have suggested that real-time management, based not on a fixed frequency or schedule, but rather on the degree of accumulation and on rainfall forecasts, may be effective at minimizing the sediment available for wash-off during a precipitation event. The town may not have enough manpower to provide real-time management; however, the town highway department has been very receptive to these ideas and has expressed interest in working with lake residents on solutions to these issues. Trouble spots for road sand accumulation in the Partridge Lake watershed include the paved roads, which include most of Partridge Lake Road and Old Partridge Lake Road. See photo below.

Photo: Road sand accumulation along Partridge Lake Road.

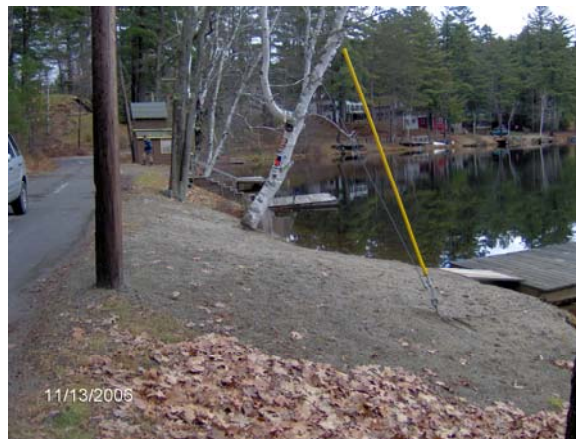
Typical beach configurations as shown in the photo taken along Partridge Lake Road (right), usually begin at the edge of the road, are steeply sloped, and meet the waters edge. By installing a permitted perched beach with a diversion trench along the upper limit of sand, overland runoff is diverted around a sloping beach, and rocks placed at the toe of the slope prevent direct washing of the sand to the lake (DES, 2007). The DES Wetlands Bureau has guidelines for establishing perched beaches to reduce the likelihood of erosion and sedimentation. The Wetlands Bureau not only requires permits for beach construction and replenishment, but also restricts the time interval between beach replenishments to once every 6 years and in general may not exceed more than 10 cubic yards of sand.

Beach improvement by landowners may be encouraged through outreach and educational materials, such as the Lake Guide developed by PLPOA. Incentives to improve beaches may include help with labor from the PLPOA and/or the town during the Phase 1 road improvements.
